References

Renovation of the sewage collector

Renovation of the sewage collector in Swarzewo

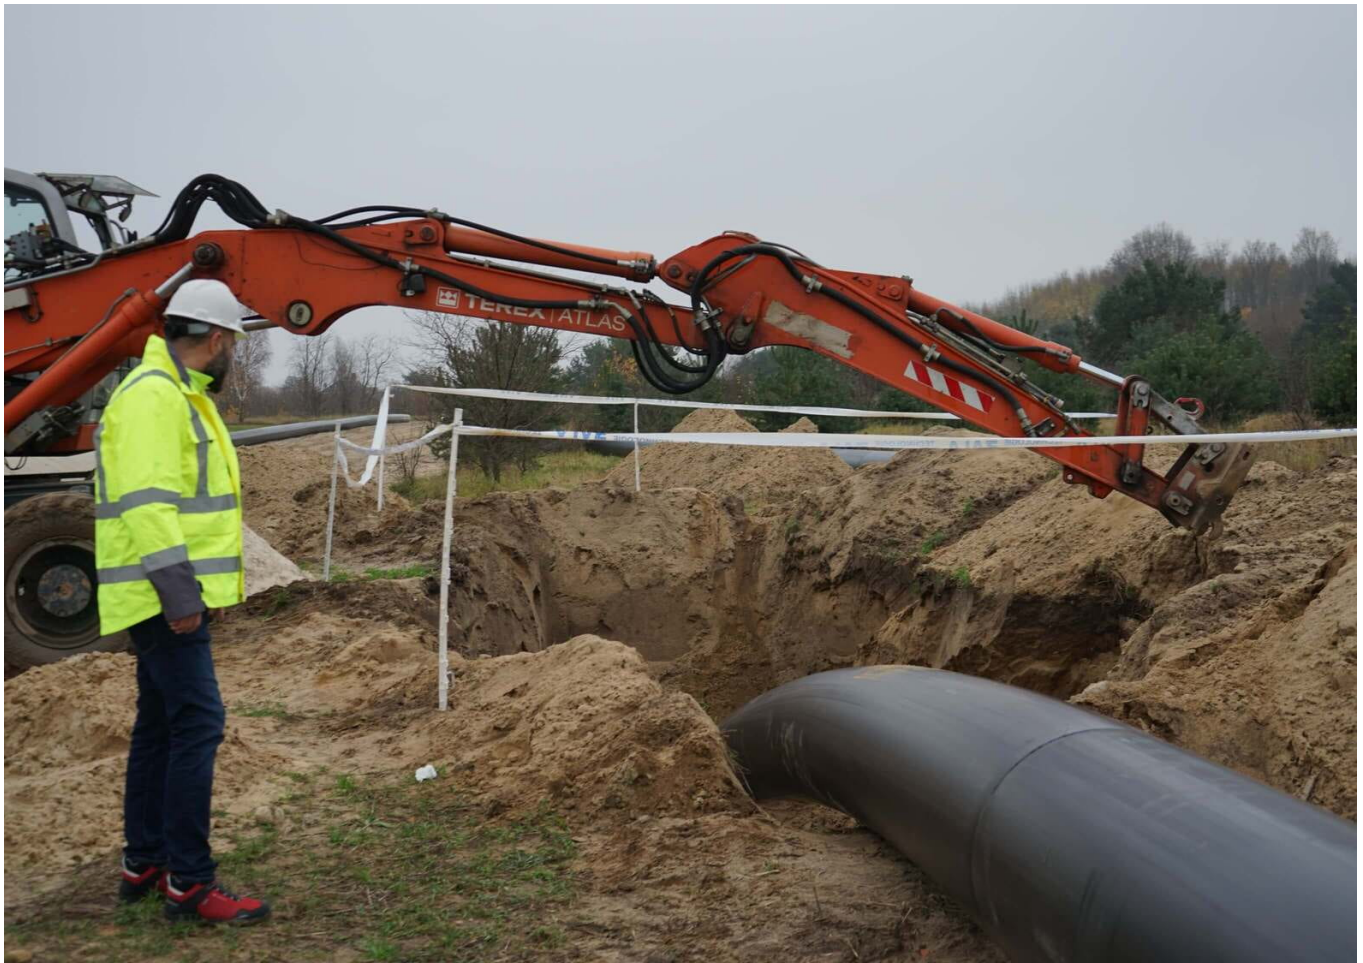
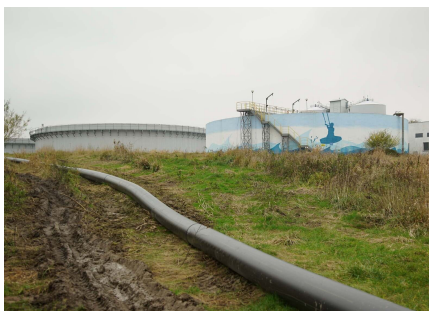
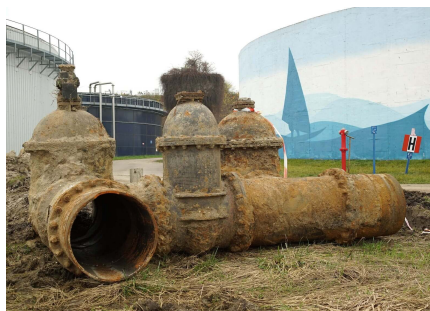
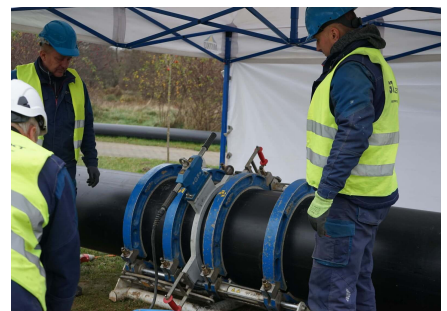
Deliveries of pipes for the described investment started in September 2021. For the renovation of the Władysławowo-Swarzewo collector pipe, it was decided to use WehoPipe PE100 DN600x23.0 PN6.3 SDR26 pressure pipes with a total length of 2,530 m. They were transported to the worksite in 12.5 m sections. The pipes were joined together by butt welding. A DN630 welding machine was used for this purpose. Deliveries were completed in February 2022.
