Water treatment plant

2.4 m diameter Weholite tank

Aeration tank to improve the water quality

Location
Iisalmi, Finland

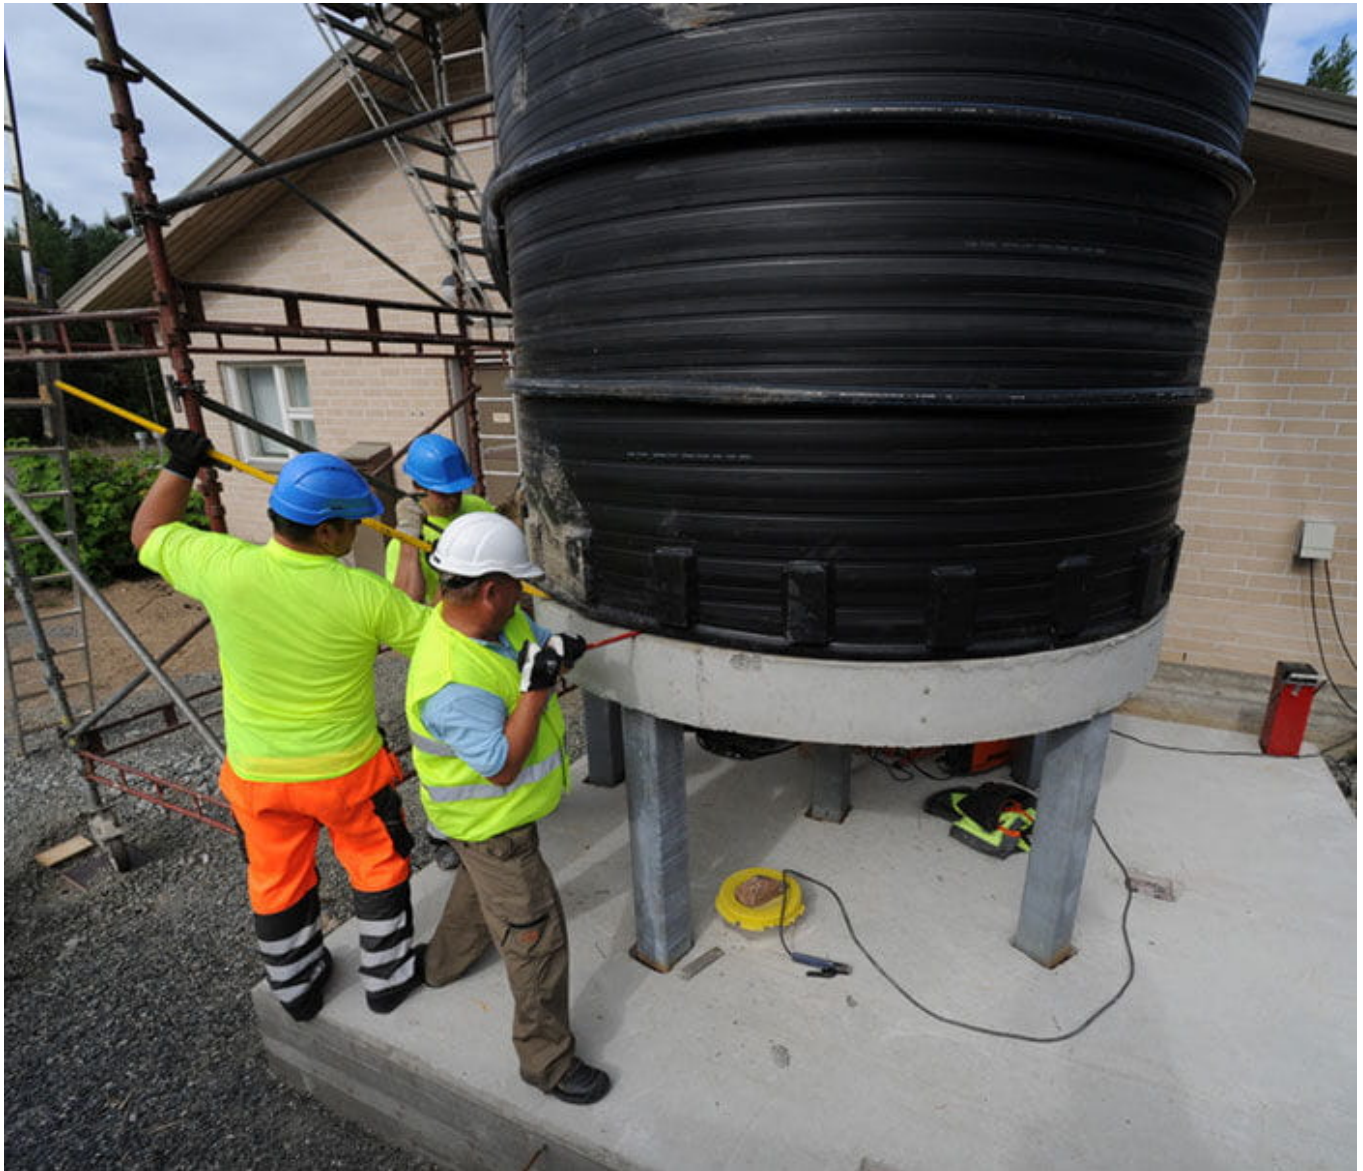
Weholite aeration tank

In aeration that improves water quality, water is led to the tower from above. The water flows through the infill mattress in the tower, removing the carbon dioxide in the raw water. Aeration can be adjusted by blowing clean air under the tower through the mattress upstream.

The amount of air does not require the tower to withstand greater pressure than normal in normal use, but the Weholite tank can also withstand the full water pressure of the tank, for example in the event of washing or disturbances.

- The concrete slab under the tower had already been made in advance. On top of the base slab, we installed feet just over a meter high, on which we lifted a round concrete slab. The tower was attached to it, says work manager Kalevi Savolainen.

Valves and piping were installed in the space under the tower. The insulation of the lower part was also supplemented. The finished tower was raised with a truck crane. - The work went as planned. Already during the installation work, guests visited the site. The insulated aeration tank is interesting because there is little space for such massive structures in a few places, Savolainen says. The contractor completed the tower by installing exterior cladding.
