References

Quick installation in the Konotopa channel

Weholite guaranteed a simple and quick installation in the Konotopa channel

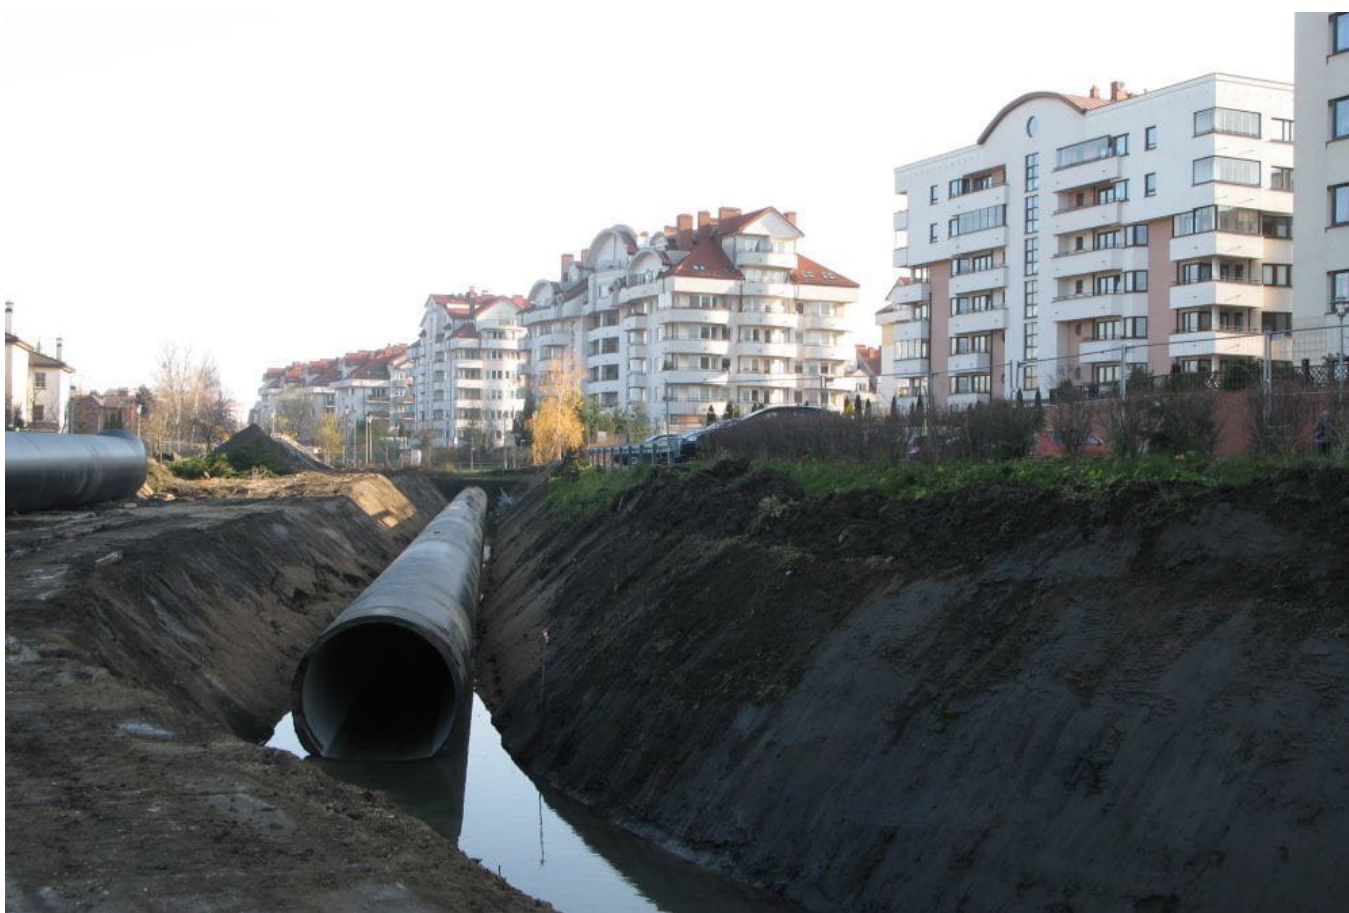
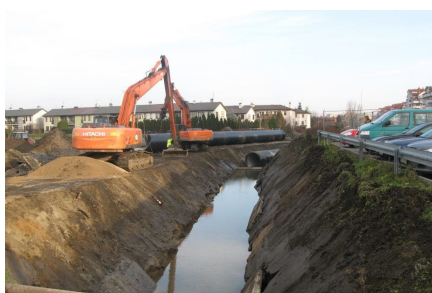
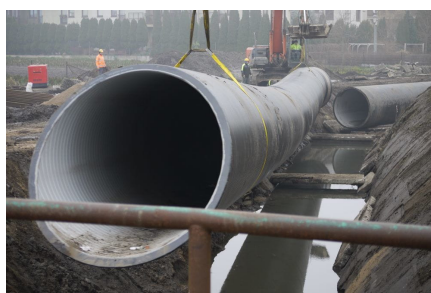
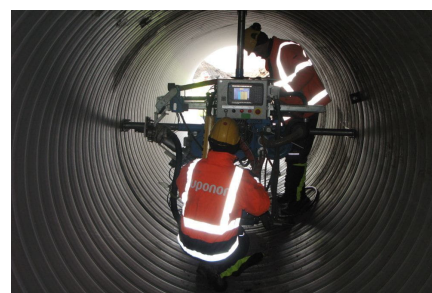
Weholite guaranteed a simple and quick installation in the Konotopa channel

Following a tender, in September 2016 Drainage Construction Company Tolos was appointed as the general contractor for the project. Uponor Infra delivered a total of 165 metres of structured-wall PE-HD Weholite, DN/ID 2,000mm SN4 pipes to the installation site. Prep work included clearing the channel of concrete slab lining, dredging the ditch to make room for the new pipeline and laying the bedding. Uponor Infra pipe service staff then joined up the Weholite pipes to form two sections. The work was carried out on dry land on the right bank of the channel, by means of automatic extrusion welding using a WLI-3000 machine. This guaranteed the 100% tightness and homogeneity of the pipeline. A 100- metre section of pipeline was then lowered into the ditch, followed by the remaining 50-metre section with a fitted bend two days later. Since the channel was operational during installation, the two connecting sections of the pipeline were raised above the water level, where they were welded together. The pipeline was then connected to a reinforced concrete inlet of the underground section of the channel. A socket- and- spigot DN/ID200mm joint was fitted onto the pipeline, connecting it to an existing stormwater channel. Finally, the ditch was backfilled. At the spot where the new pipeline meets the open section of the channel, an outlet was secured with a steel grate to prevent unauthorised entry. The installation was completed in December 2016.
